# Solving The Crimper Enigma

**Part III***By Van Durrett, Vice President, DM&E Corp., USA**e`nig`ma something that is mysterious and seems impossible to understand completely*

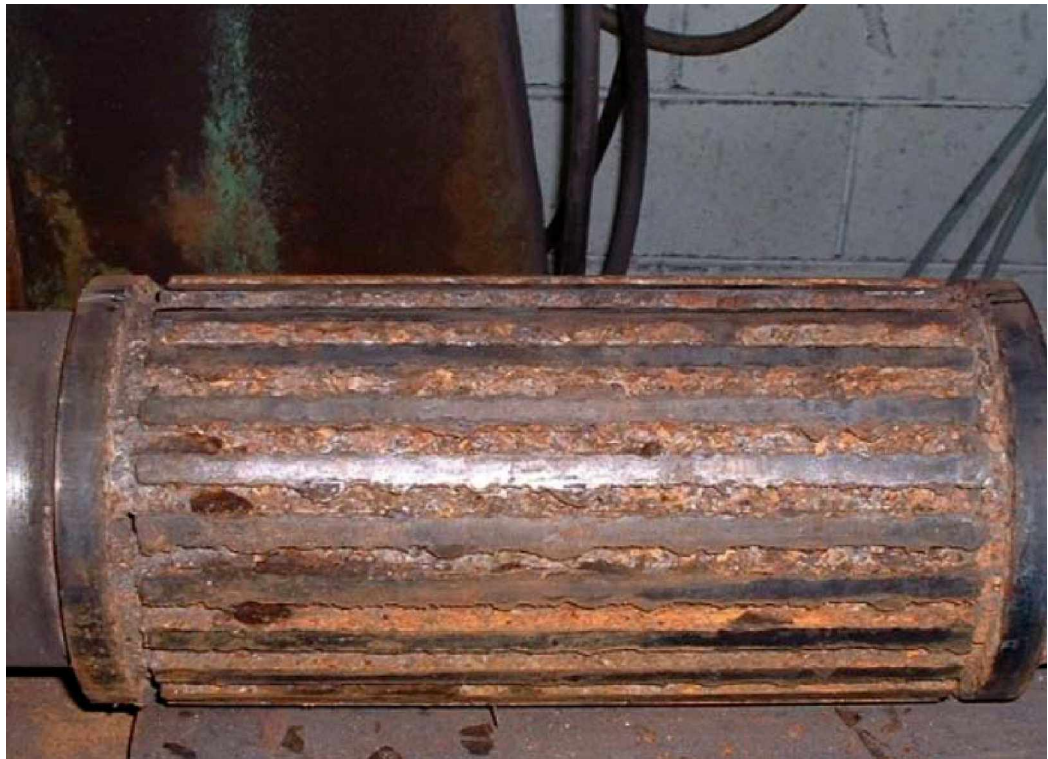
*Corroded roll*

The problems are poor cooling water circulation and tire cracking. We mentioned above that cooling water is circulated around the inner surface of the tire to regulate the tire temperature. Failure to use properly treated water can result in a roll with the cooling channels nearly blocked by rust and mineral deposits.

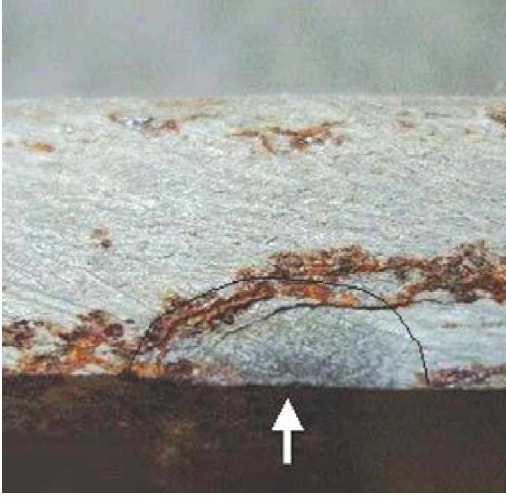
*Microscopic crack*

Independent laboratories have confirmed the problem, and the solution is simple. The explanation is complex, but can be condensed. First, as we described above, the tire is expanded with heat and when cooled shrinks against the outside of the shaft. This leaves the tire stretched over the shaft. The inner fibers of the tire are subjected to the maximum stress. When cooling water containing chlorine is used, the chlorine attacks the inner fibers of the tire, creating

small corrosion cracks. The small cracks become a stagnant reservoir, the chlorine concentrates, and the attack continues. As the crack deepens, the process becomes autocatalytic. It becomes self-sustaining and accelerates until the cross section is weakened. Ultimately, the area under attack fails and the crack is propagated down the length of the tire.
